INDOOR AIR QUALITY ASSESSMENT

Quarry Hill Community School 43 Margaret Street Monson, Massachusetts

Prepared by:
Massachusetts Department of Public Health
Center for Environmental Health
Bureau of Environmental Health Assessment
Emergency Response/Indoor Air Quality Program
July 2004

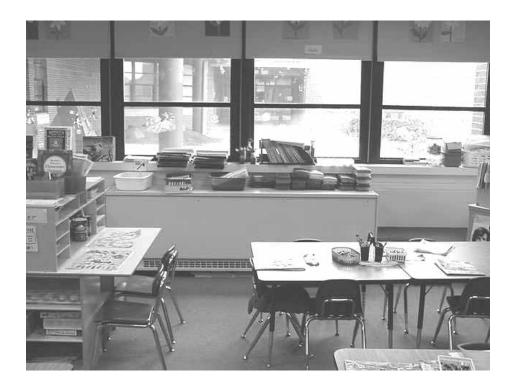
Fresh air in classrooms is provided by unit ventilators (univents) (Figure 1, Picture 1). Univents draw air from outdoors through a fresh air intake located on the exterior walls of the building and return air through an intake located at the base of each unit. The mixture of fresh and return air is drawn through a filter and heating coil and provided to the classroom from the univent by motorized fans through an air diffuser on the top of the unit. Univents were operating in all areas surveyed; however, a number of

units were obstructed, preventing airflow. To function as designed, univent diffusers and returns must remain free of obstructions.

Univents

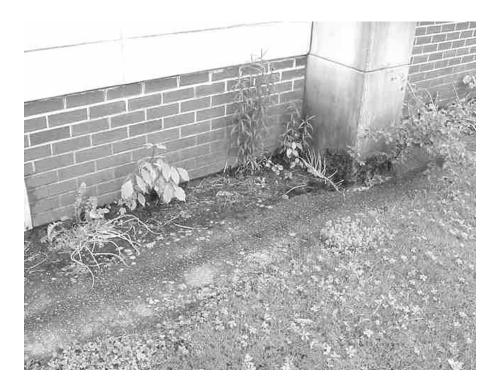
Of note is the lack of roof gutters and downspouts along the sloped roof of the building. The exterior of a number of wings had extensive moss growth on the building apron, brick and pilasters (Pictures 2 through 4). A substantial source of water is needed for moss to grow. The source appears to be rainwater pouring from the roof onto the tarmac below. As a result of chronic water exposure, the soil beneath this area has become compressed, resulting in the tarmac becoming pitched towards the building. On May 28, 2004, the building was examined during a heavy rainstorm during which water had accumulated in deep pools against the building (Picture 5).

Extensive Moss Growth on the Building Apron, Slab Exterior Walls and Pilasters

- 2. Remove all plant and moss growth along the building exterior.
- 3. Seal the wall /slab seam inside classrooms with an appropriate sealing compound to prevent cold air/moisture penetration.

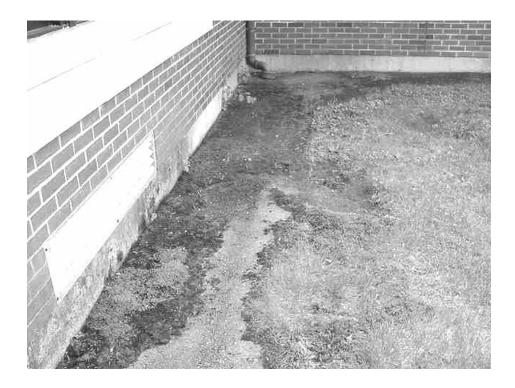
Extensive Moss Growth on the Building Apron, Slab Exterior Walls and Pilasters

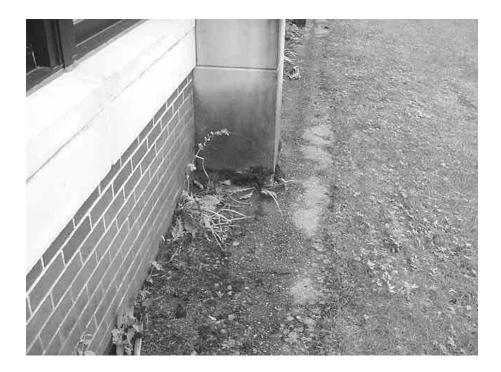
Extensive Moss Growth on the Building Apron, Slab Exterior Walls and Pilasters

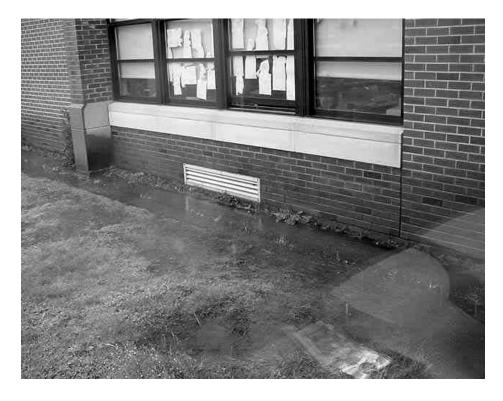
Pooling Water against Exterior Wall of School

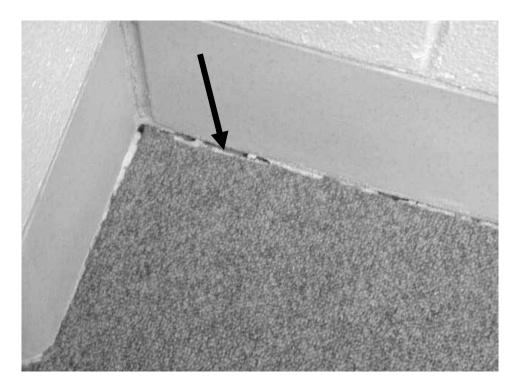
- An open seam between the exterior wall and slab (width approximately 4 centimeters) was seen in rooms 315 and 316 (Picture 6) directly beneath the carpet.

- Insect bodies were under the carpet, indicating a means of ingress from the
 outdoors. The most likely means of ingress appeared to be the wall/slab seam.
 (Note: a live insect was seen entering the crack during the assessment).

- A cementitious material appeared to be applied between the exterior wall and the slab on the outside of the building. Cracks around this material were found, which may serve as a means for insects and water vapor to enter the building. Other cracks were noted in wall seams. School staff reported that cracks in classrooms appeared during construction of the new high school north of the QHCS (Maps 2-4). The combination of blasting during the construction of the new high school combined with the heavy snow load carried by the building structure during the winter of 2002-2003 may have played a role to open the seams and cracks observed.

An Open Seam between the Exterior Wall and Slab

- 4. Reestablish the seal between the slab and exterior curtain wall to prevent air and water penetration.
- 5. Replace walk-off mats at the end of hallways with a non-porous material (e.g., tile with a rubber tread mat).
